## THESIS

The Effect Of Multiple Weld Repairs  
On The Fatigue Resistance Of  
Welded Aluminum Alloy 5083-0

John R. Panico

December 1979

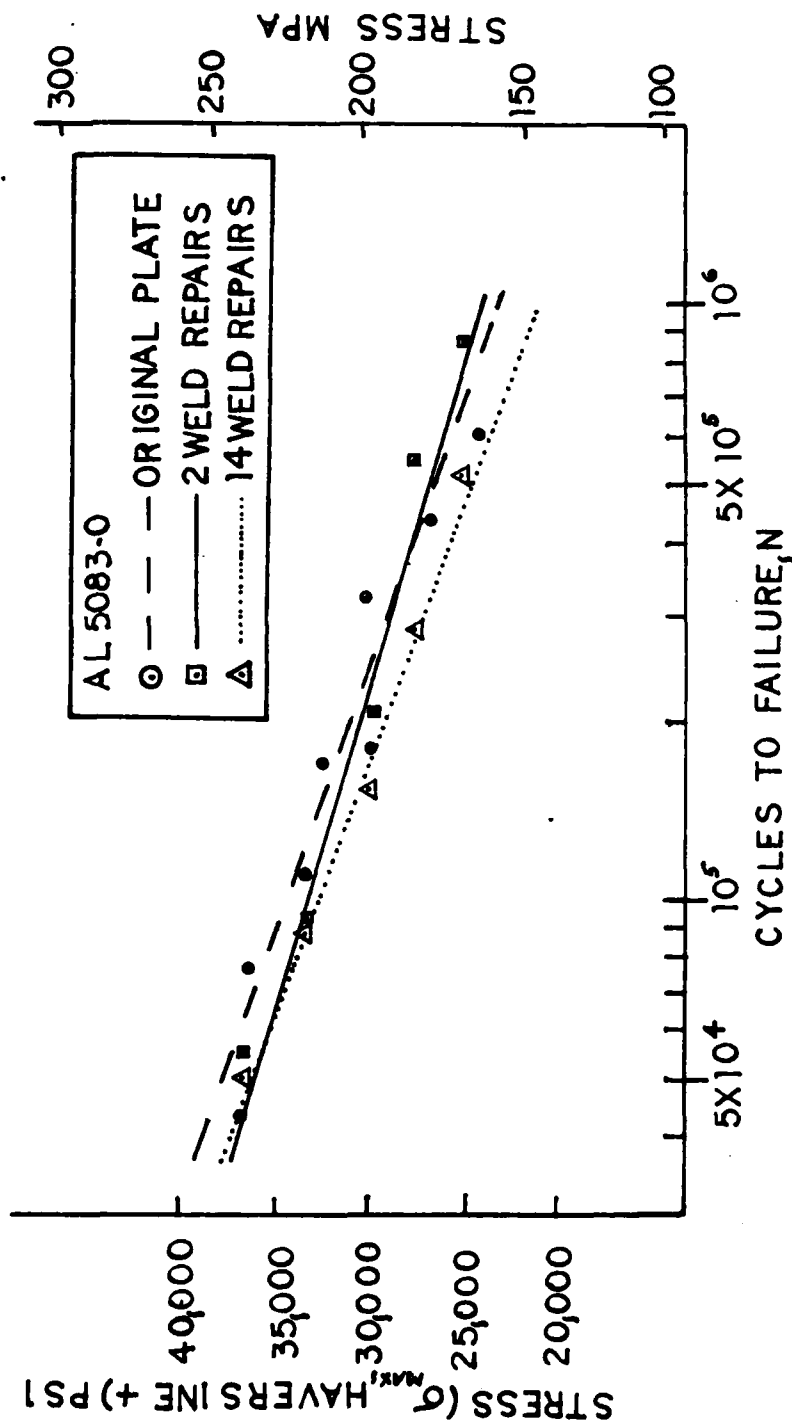
Figure 15 is a comparative graph which shows the relation of the three fatigue curves (original plate, two repairs, fourteen repairs). There is only a slight difference between the results of these tests, however there appears to be a slight decrease in the fatigue resistance of the fourteen weld repaired sample as compared to the original plate and the twice-repaired plate. It should also be noted that for maximum stresses above about 27000 PSI (186 MPA) the twice weld-repaired specimen appears to be stronger than the original plate, possibly due to scatter in the data.

It is most significant that all the weld-repaired samples failed in the weld area. This answers the question posed in Section III above. The fatigue crack initiation remained in the weld area. It did not shift into the HAZ as a result of coarsening and cracking of inclusions, induced by increasing numbers of weld repairs. This also explains the similarity between the S-N curves in Figure 15. Since the failure occurs in the weld it makes little if any difference how many times the material is weld repaired. Additionally, the similarity in the properties of the filler metal to that of the original plate explains the close correlation of the original plate fatigue data to the welded plate data for the conditions tested.
